# Classification, Effects, and Prevention of Build Defects in Powder-bed Fusion Printed Inconel 718

Prepared By: Arthur Brown

NASA

Marshall Space Flight Center

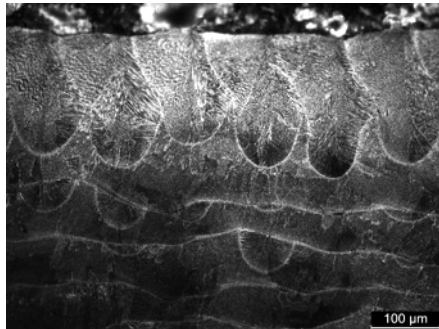
MSFC M1

- As-built microstructures are dominated by the characteristics of the melt pool, which vary based on build parameters.
- Following heat treatment, the microstructure recrystallizes and resembles the wrought microstructure, with some expected grain size variation. IN718 derives strength properties from precipitates in the nickel matrix, which are produced during the solution and aging heat treatments.
